construction engineering research laboratory

TECHNICAL REPORT M-283 November 1980

PAVEMENT EVALUATION AND REPAIR RECOMMENDATION SIERRA ARMY DEPOT, AMEDEE AIR STRIP

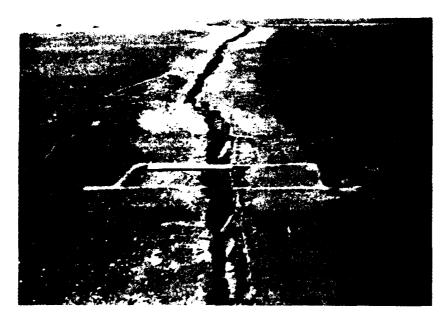
Figure 7. Cut #1.

Cut #1 (Figure 7) was across a 4-inch-wide crack extending through the full depth of the top AC surface. There was no evidence of the crack in the base or on the old AC surface below.

(a) Pavement before cut showing 4-inch wide crack.

(b) Pavement after cut showing crack to extend through the full depth of the top AC surface.
